NPIC/CSD 548/65

27 OCTOBER 1965

VINH COMPLEX
NORTH VIETNAM
1840N 10540E
[REDACTED]

NATIONAL PHOTOGRAPHIC INTERPRETATION CENTER

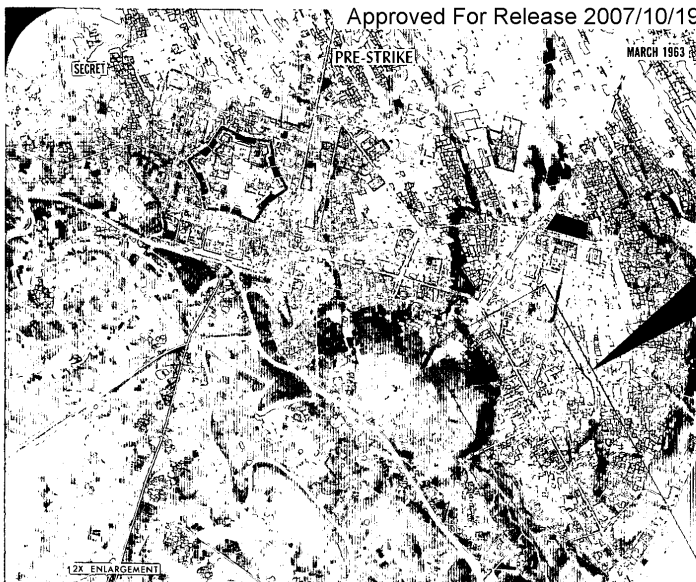
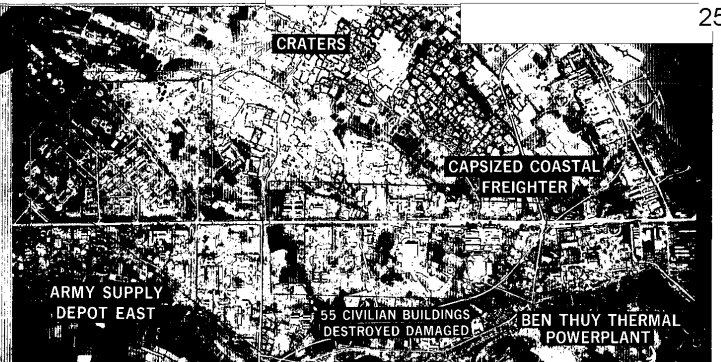
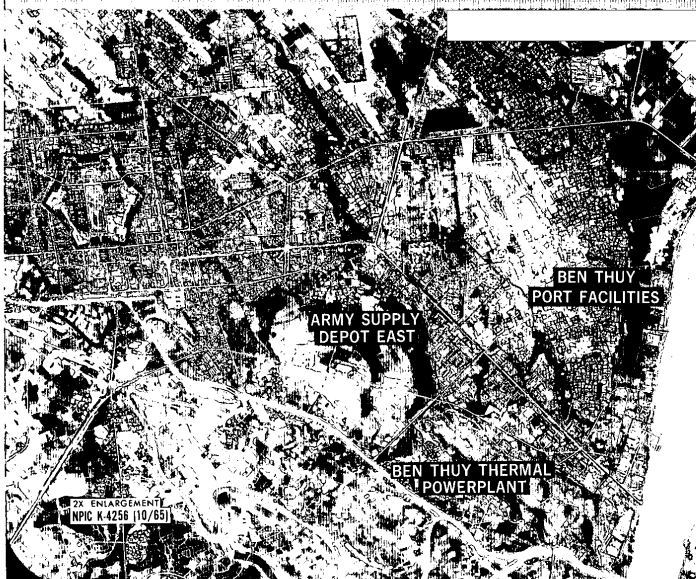
VINH COMPLEX

1. PRE-STRIKE PHOTOGRAPHY OF MARCH, 1963 REVEALS VINH COMPLEX.

[REDACTED] REVEALS THIRTY STORAGE/WAREHOUSE AND SHIP REPAIR BUILDINGS HAVE BEEN DESTROYED OR DAMAGED AT BEN THUY PORT FACILITY. NUMEROUS SUPPORT BUILDINGS IN THE FACILITY HAVE ALSO BEEN DESTROYED OR DAMAGED. A CAPSIZED COASTAL FREIGHTER IS OBSERVED NEAR THE PIERS.

3. POST-STRIKE PHOTOGRAPHY OF [REDACTED] REVEALS APPROXIMATELY FIFTY BUILDINGS TO BE DESTROYED/DAMAGED AT VINH ARMY BARRACKS CENTRAL NE.

[REDACTED] REVEALS ELEVEN LARGE STORAGE, EIGHT ADMINISTRATION, TWO MESSHALLS, TWENTY-TWO BARRACKS, AND NUMEROUS SMALL SUPPORT BUILDINGS HAVE BEEN DESTROYED OR DAMAGED AT VINH ARMY BARRACKS AND SUPPLY DEPOT. BEN THUY THERMAL POWER PLANT IS INOPERABLE. THE TRANSFORMER YARD AND NUMEROUS SMALL SUPPORT BUILDINGS IN THE TARGET AREA HAVE BEEN DESTROYED AND THE BOILER AND GENERATOR ROOMS HAVE BEEN SEVERELY DAMAGED. FIFTY-FIVE CIVILIAN STRUCTURES ARE DESTROYED/DAMAGED. ADDITIONAL PROBABLE SMALL CIVILIAN HOUSING UNITS HAVE BEEN DESTROYED ALTHOUGH AN ACCURATE ASSESSMENT IS IMPRACTICAL WITH AVAILABLE PHOTOGRAPHY.
